Short note

Karst drainage of lake Chakanbacán and its relation to Icaiche Formation

Rosa M. Leal-Bautista^{1,*}, Eugene C. Perry², Jesús Alvarado-Flores³, Liliana Alzate-Gavira⁴, Jorge A. Domínguez-Maldonado⁴, Raúl Tapia-Tussell⁴

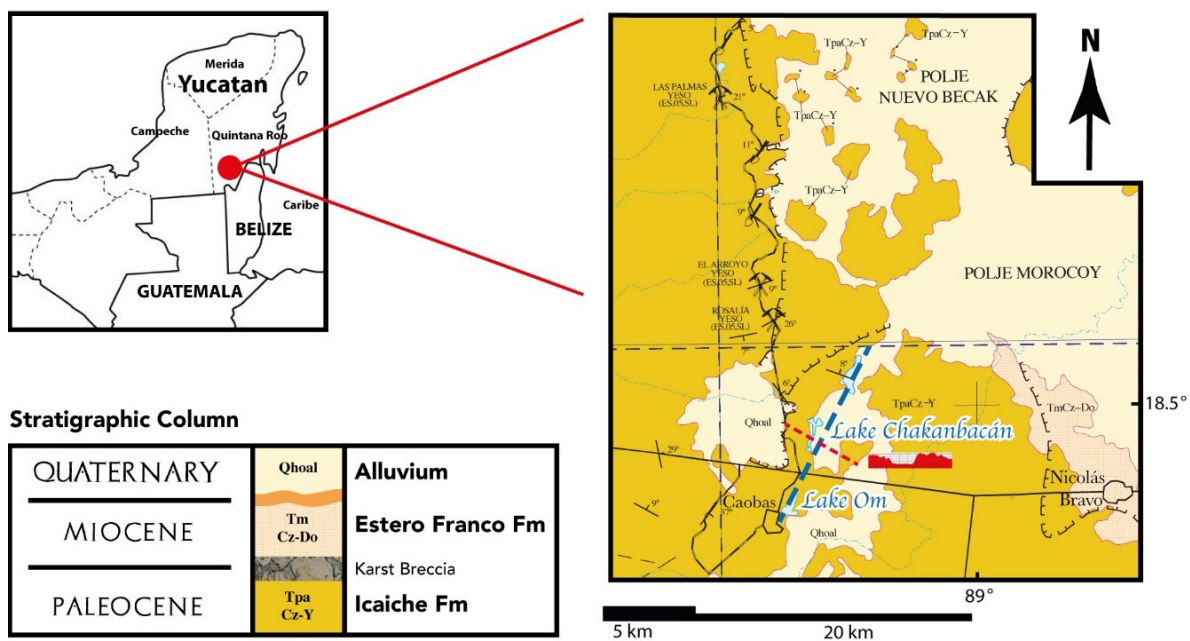
Figure 1 Geologic setting of Lake Chakanbacán. The lake lies in a depression 8.9 km long shown as a gray dashed line in the Figure. This depression extends in a NNE direction from Lake Om (elevation 128mamsl, 18.44°N, 89.1°W) in the south and disappears into the floor of Polje MNB at an unnamed lake (elevation about 100 mamsl) at 18.52°N, 89.06°W in the north. Note that several small exposures (“islands”) of rocks of the Icaiche Formation rise from the floor of Polje Nuevo Becak to the north. These erosional remnants are a typical feature of karst terrains. The depression containing Lake Chakanbacán is most conspicuously developed along the ESE-WNW red line in the Figure. The inset topographic cross section (in red) shows that the depression passes between >30m banks of rocks of the Icaiche Formation. In the partial geologic column (above) rocks are shown using the map symbols of this Figure, which are those used by the Sociedad Geológica Mexicana. “Y” in the symbol for the Icaiche Fm stands for yeso (gypsum). Quarries shown are inactive but once mined gypsum. (Figure 1 is redrafted from a portion of SGM map sheet Chetumal. E16-4-7).

Good circumstantial evidence that the active part of the karst aquifer beneath Lake Chakanbacán is comprised largely of dissolving gypsum; such a study comes from the longitudinal profile of the NNE-SSW depression in which the lake occurs (Figure 1) and of the known occurrence of dissolving gypsum encountered in the now-abandoned well in Caobas. At the southern end of the chain of water bodies, Lake Om at Caobas has an elevation of about 130m and is barely depressed below the surrounding terrain, whereas at the northern end of the depression, the terrain level is about 100m and the depression has merged into the surrounding polje. In a transverse profile in the middle (Figure 1), the banks of Lake Chakanbacán are about 30m below the terrain (topographic cross section inset into Figure 1). We think it reasonable that these observations are consistent with the hypothesis that dissolution of gypsum is proceeding from north to south as the Morocoy portion of Polje MNB expands by dissolution of gypsum and the concurrent collapse of overlying rock.

1) Assume that the 30 m-deep depression in which Lake Chakanbacán lies (Figure 1) was excavated by dissolution of gypsum. (The setting is right; the thickness is right (Perry *et al.*, 2019).)

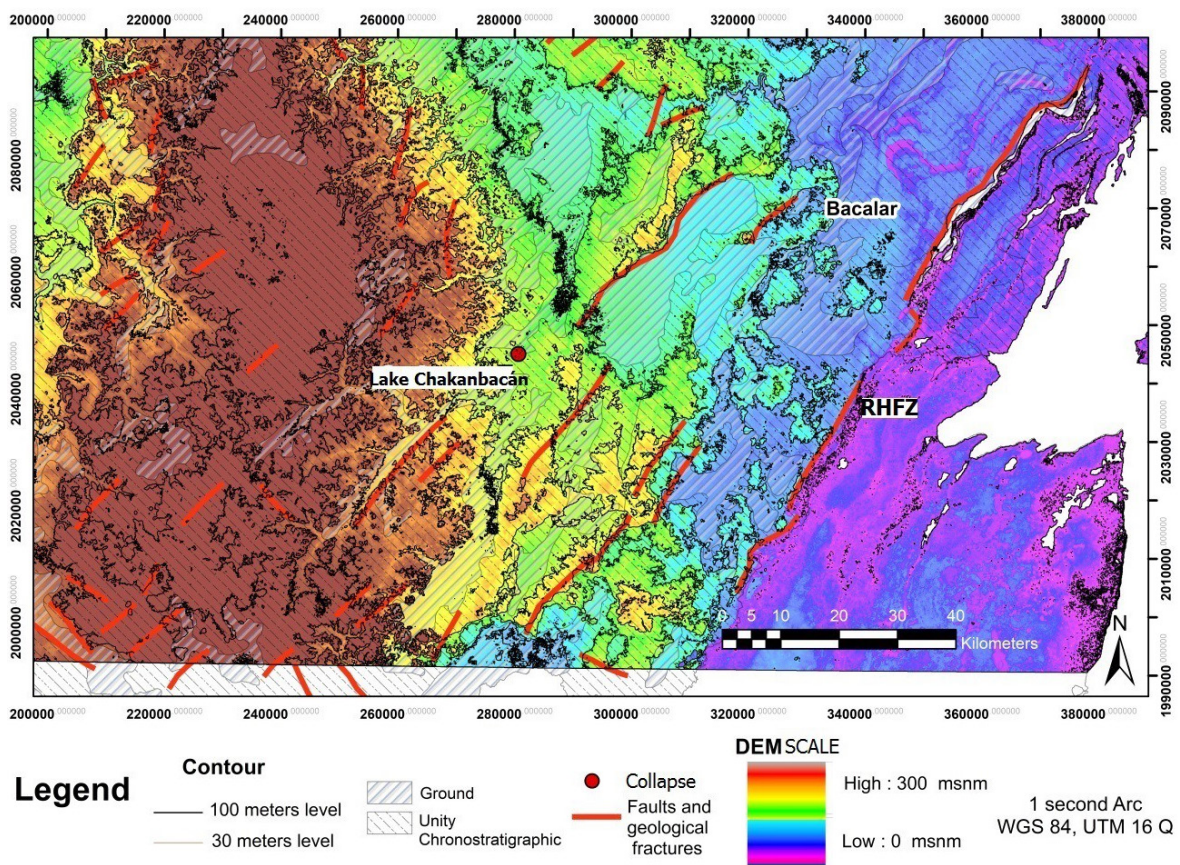
Digital Elevation Model (DEM), South of the Yucatán Peninsula

Figure 2 Lake Chakanbacán runs in a direction parallel to the Rio Hondo Fault Zone (RHFZ) as the SGM (2007) indicates and also it is at the west margin of the topographic change from the high to the lowest point of elevation at this Figure. Map made by Dr. José Luis Hernández-Martínez source SGM, (2007).

tion of Lake Chakanbacán to Polje MNB makes it probable that in observing the disappearance of water from Lake Chakanbacán, we have captured in real-time the process by which numerous large poljes of Campeche and southwestern Quintana Roo have formed and may currently be increasing in area. 2) Gypsum (CaSO₄•2H₂O) is the probable source of most of the high sulfate content of groundwater and surface water in the Mexican Yucatán Peninsula (Perry *et al.*, 2002; Perry *et al.*, 2009; Perry *et al.*, 2019; Bauer-Gottwein *et al.*, 2011; Wagner, 2009). Perry *et al.*, 2021 have proposed that the recharge area for high sulfate groundwater discharging in the Rio Hondo Fault Zone of eastern Quintana Roo lies precisely in the area around Lake Chakanbacán see Figure 2.

de Quintana Roo (PROFEPA_QROO) the help in the field from Ing. Noé Demetrio Kú Chan (PROFEPA_QROO), and the contribution of Dr. José Luis Hernández-Martínez Posdoc- CONACyT, for the map Figure 2.

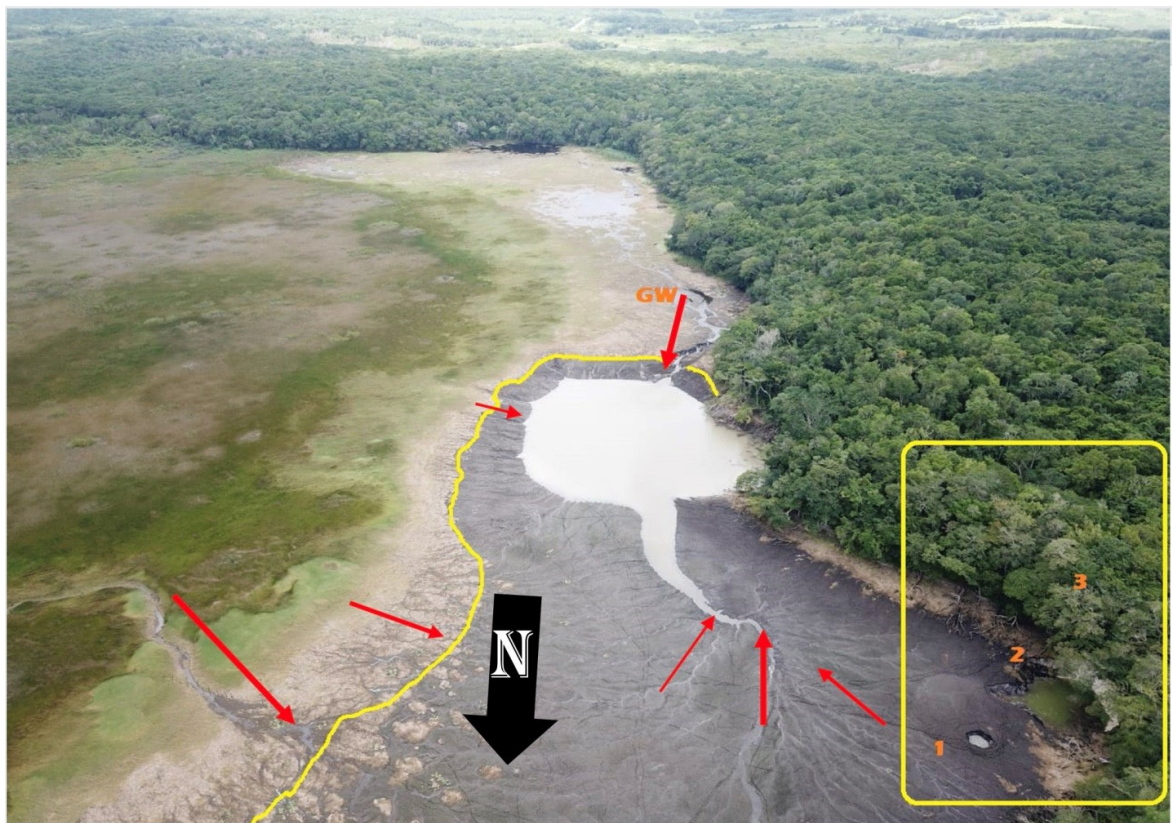
Figure 3 Drone view of bed of drained lake taken on August 20, 2018. Points 1 and 2 are drain sites; Point 3 is the slumped bank where gypsum normally covered by soil is exposed. GW indicates a groundwater seep where water was sampled. Arrows trace direction of surface flow. The major drain appears to have been beneath the water body ponded in the center of the Figure. *Drone photograph courtesy of Noé Demetrio Ku.*

On August 26, 2018, 5 days after the Lake Chakanbacán drainage event was discovered, the lake site was visited by a team from the Centro de Investigación Científica de Yucatán (CICY) in company with local residents from ejido Om and by Noé Demetrio Ku from PROFEPA. The group was able to examine lake collapse sites 2 and 3 (Figure 3) but decided the water-saturated ground around site 1 was too unstable to allow safe collection of water from that site. The group noted various indications of mass movement in the bank of Lake Chakanbacán. This evidence included tree trunks leaning toward the lake and small fractures in the ground along paths leading to the collapse zones. The group conducted a reconnaissance toward the southwest, and at point GW (Figure 3) encountered a spring feeding a stream of water that flowed toward the zone of collapse (Leal-Bau-

The rapid outflow of groundwater from spring GW and from other sources along the lake bank, such as in the left foreground of the picture, can be seen in Figure 3. This flow confirms the presence of a shallow perched water table separated by lake clay and argillaceous sediment from a deeper karst aquifer into which it is obvious that Lake Chakanbacán must have drained.

A question we have not addressed is what was the proximate cause of the August 2018 Lake Chakanbacán event? A reasonable guess would be that as a result of late summer rain, rising lake elevation had acted like a toilet plunger, pushing through abundant mud like that seen in the lake bed (Figure 3) that had clogged the drain. *But we don't know.* We have been unable to obtain local precipitation data for the period.
